**NEW SITE IDENTIFICATION (NSI)****Part A – NEW SITE IDENTIFICATION INFORMATION****(To be completed by the Task Lead for New Site)**

<b>1. Site Title:</b> Fuel Reprocessing Complex Potential releases  (Use known common names, location descriptors and or processes near or associated with the suspected inactive waste site.)	<b>Site Code:</b> CPP-117, CPP-118, CPP-119, CPP-120, CPP-121, CPP-122, and CPP-123  <b>NSI Evaluation Initiation Date:</b> November 22, 2004
<b>2. Task Lead For New Site:</b> Mark R. Cole & Paul J. Smith	<b>Phone:</b> 526-0540, 526-0611
<b>3. NSI Coordinator:</b> Wendell Jolley	<b>Phone:</b> 526-5990
<b>4. Initiator or Initial Observer:</b> Wendy Savkranz	<b>Phone:</b> 526-4858

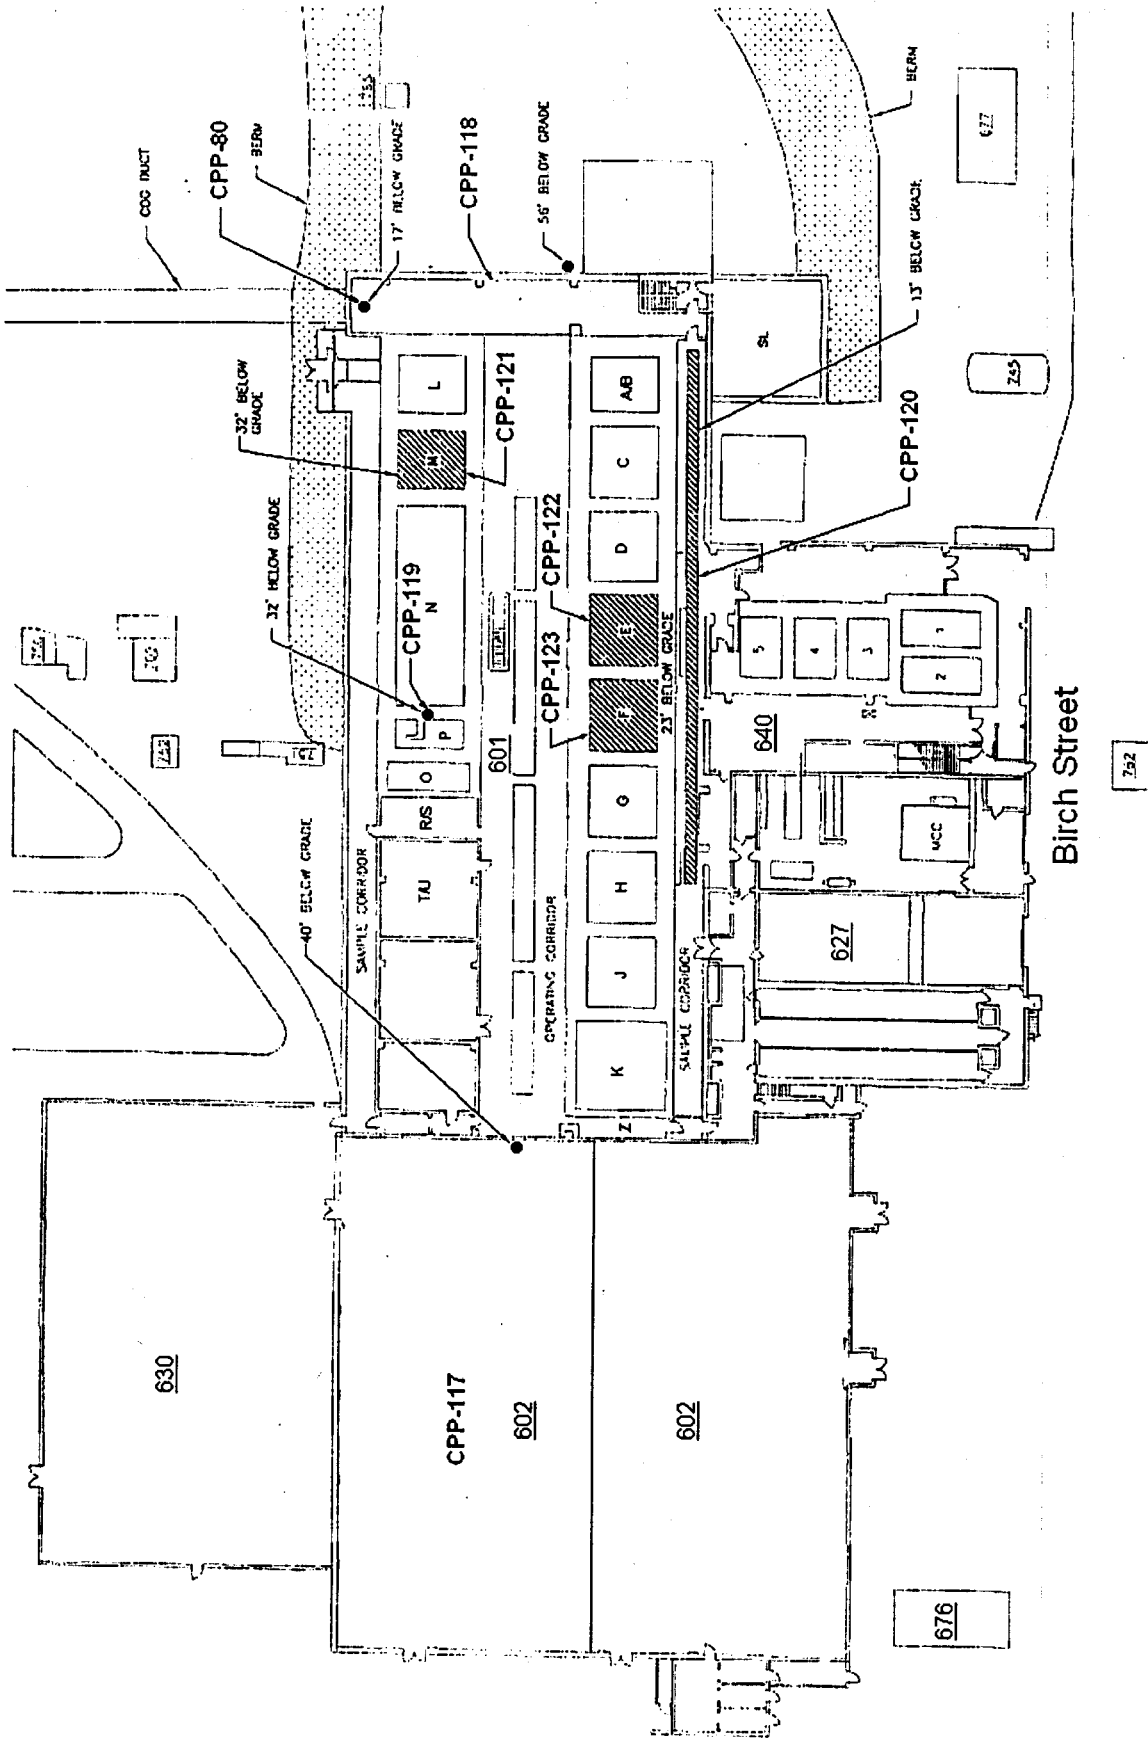
These potential releases would be in addition to existing release site CPP-80, a Group 2 site located under CPP-601. The following provides a description of the potential release sites and available information. The attached drawing identifies the approximate location for these potential releases.
